STS-102 FLIGHT READINESS REVIEW

February 27, 2001

Orbiter

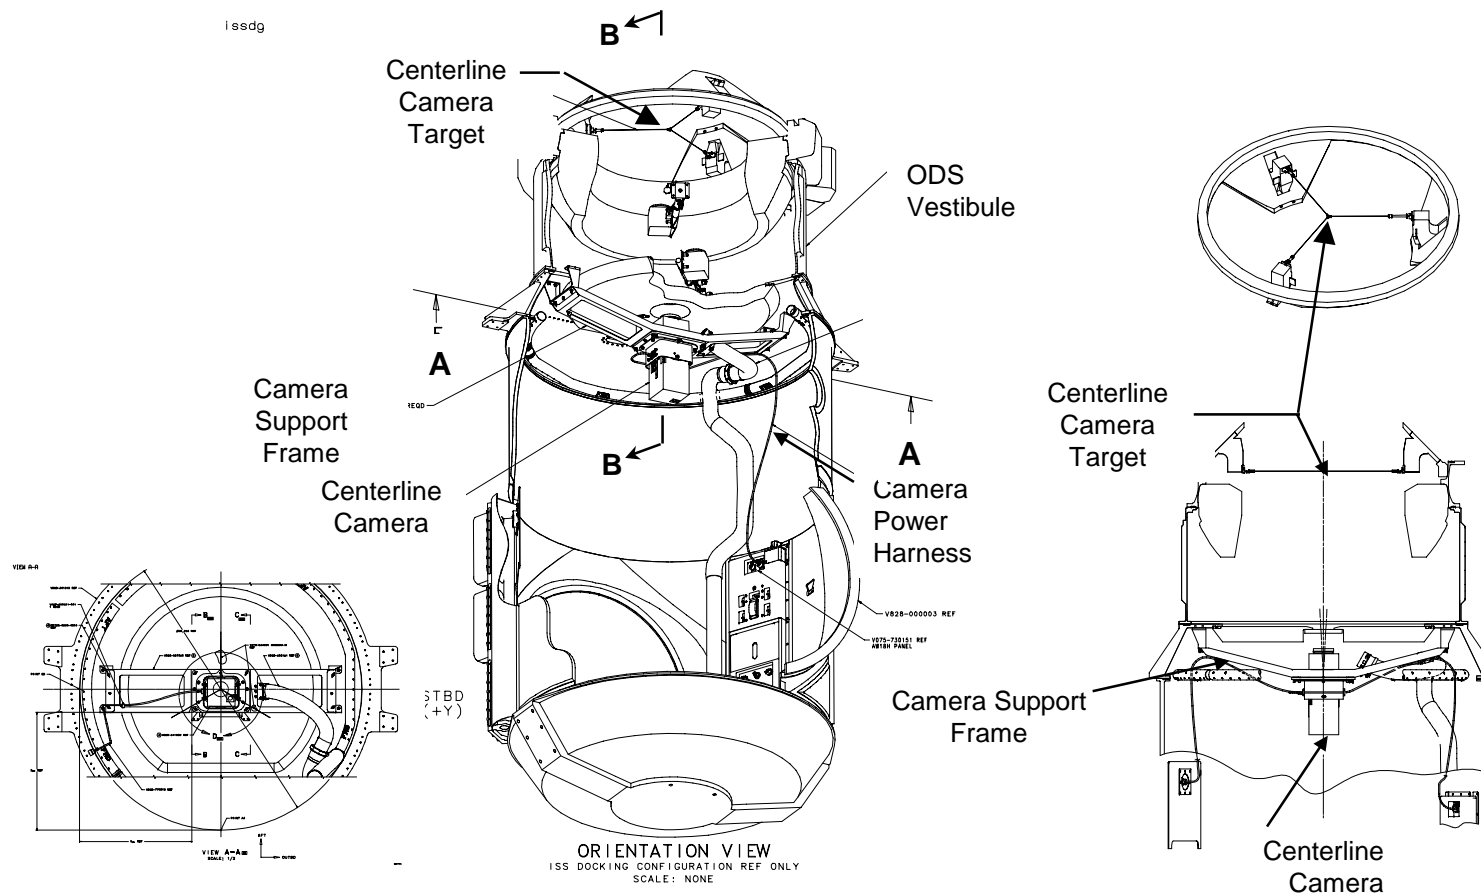
**ODS Overview Showing
Centerline Camera Components**

- STS-92 misalignment was observed prior to docking
 - Primary camera – marginal
 - Secondary camera – 0.4 inches
- System design requirement is for the camera installation to be within +/-0.25 inch in translation, +/-0.5° in combined pitch/roll and +/- 0.5° in yaw to the docking base centerline
- APAS procurement spec, certification test data and mission analysis indicate significantly higher misalignments can be tolerated
 - Translational: 4.2 in (radial)
 - Angular: +/- 4.0° (each axis)
 - Rotational: +/- 4.0°

- Evaluation of possible causes was defined utilizing fault tree analysis
- Testing on OV-104 was unable to re-create the anomaly
- Alignment testing on OV-103 was able to recreate the STS-92 flight misalignment
 - Problem traced to improper installation of the camera and/or crossbeam during original ground alignment pre-STS-92
 - Subsequent good installations on-orbit resulted in misalignment
 - Current alignment specification does not have specific requirements for proper camera installation verification
 - PRT evaluating updating the OMRSD and alignment specification
- For STS-102, both primary and backup cameras have been re-aligned using an updated TPS which included requirements to verify no gaps at the camera/crossbeam and crossbeam/airlock (8) interfaces

- Realignment of cameras on OV-103 has been performed and confirmed that both the primary and backup centerline cameras are aligned within specification
- APAS performance capabilities can accommodate camera misalignment larger than that recently observed with no risk to a successful docking

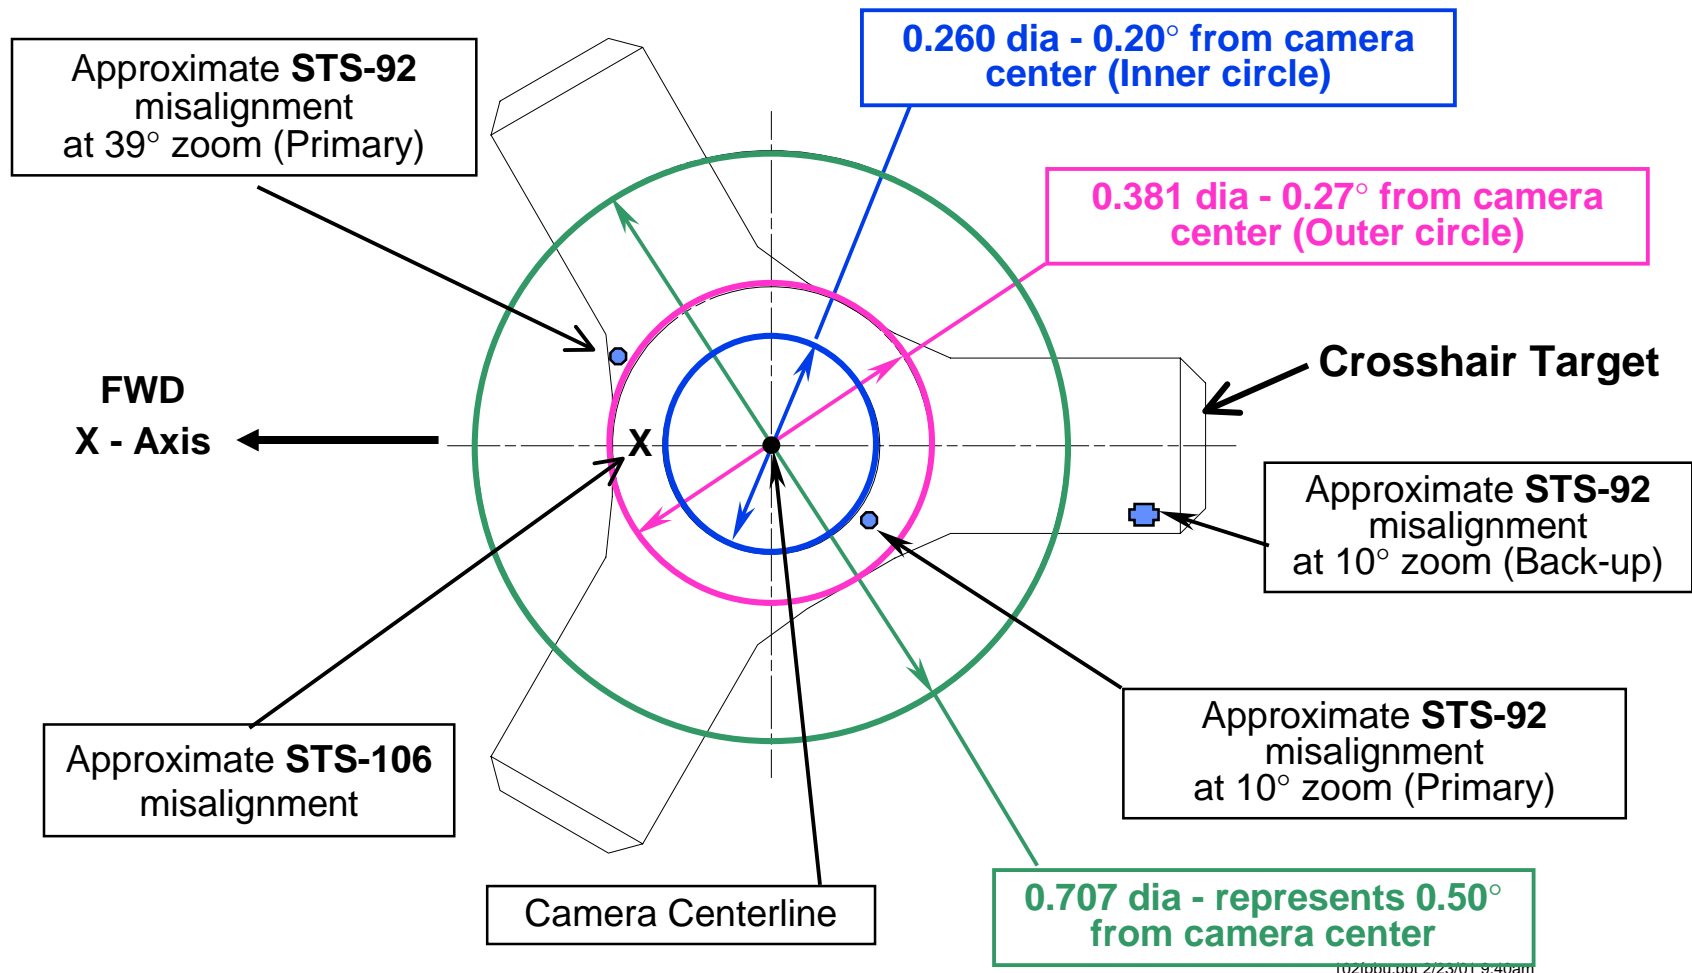
Target Detail View Showing STS-92 and STS-106 Misalignment

- APAS capability provides significant margin to accommodate combination of actual docking misalignment and observed centerline camera misalignment
- Slight centerline camera misalignments like those observed during STS-106 and STS-92 had no significant effect on actual alignment at docking

- Misalignment to a similar degree was observed with the primary centerline camera during STS-106 (OV-104) in preparation for docking
- During STS-106 preparations for un-docking, the camera was reinstalled and was observed to be nominally aligned
- The backup camera was not used during STS-106

- Based on an assessment of APAS performance capabilities and previous mission docking alignment data, centerline camera misalignments on the order of those observed during STS-106 and STS-92 represent no risk to a successful docking

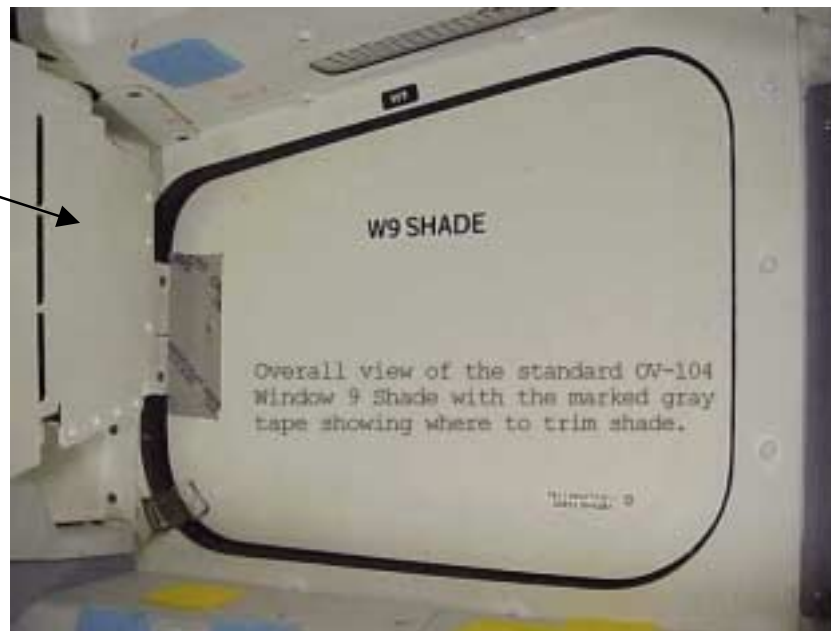
MEDS MDU
Enclosure

- Interference was found between the Window 9 Flight Shades and the monitor bracket for the MEDS MDU
- Modifies the Window 9 shade on all MEDS modified Orbiters
- Modified shades scheduled for delivery to KSC on 1/11/01

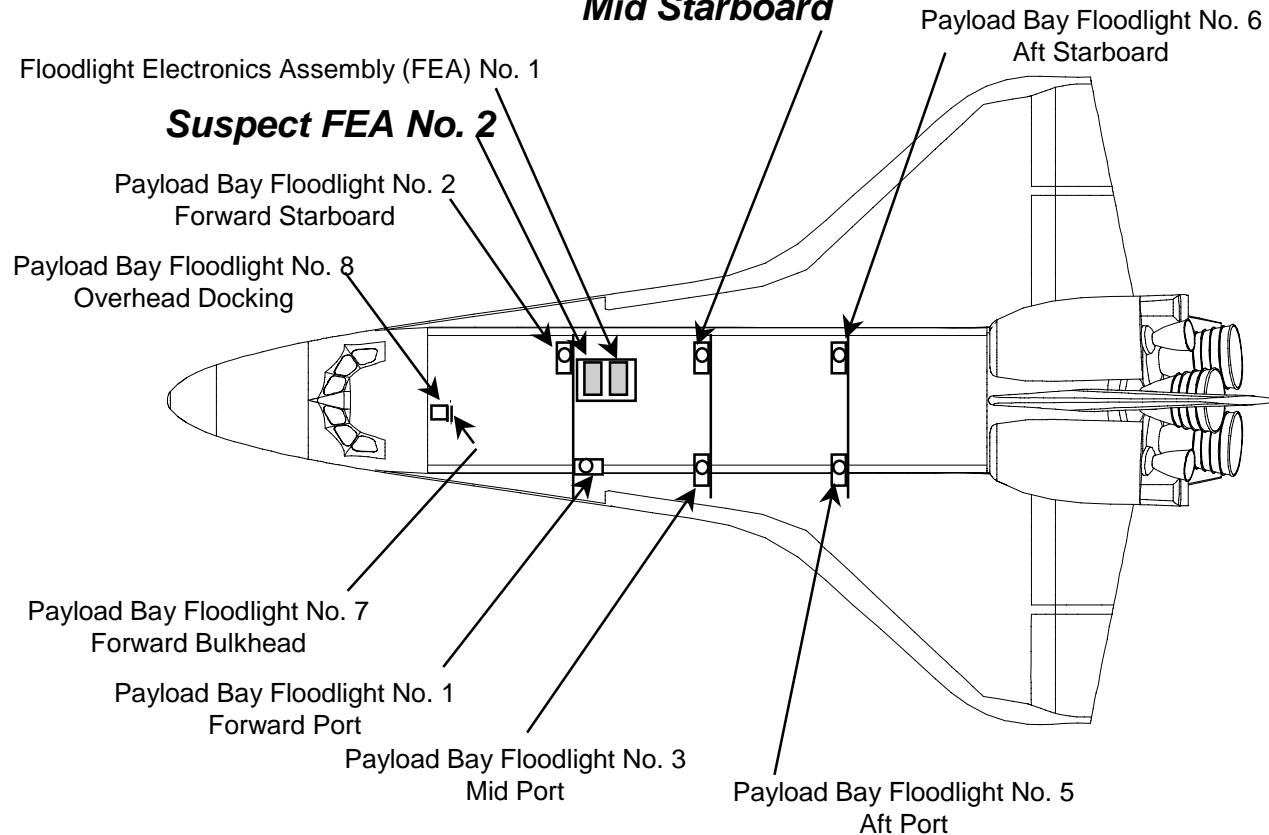
Failed Payload Bay Floodlight No. 4 Mid Starboard

- During payload bay door closure on STS-98 (OV-104), the mid-starboard payload bay floodlight #4 failed to turn on when commanded by crew
 - Current measurements of Main Bus C indicated RPC trip (approx. 14 amp excursion)
 - 10 amp RPC 7 in MPCA #3

- Multiple loss of payload bay floodlights may impact mission success
 - Loss of lighting could cause crew to utilize alternate method (handheld spotlight) for verification of payload bay latch operation

- OV-104 Floodlight Electronics Assemblies (FEAs) are modified and have a current output of 1.3 amps
- FEA #2 provides power to payload bay floodlight #4
- Main Bus C current measurements point to most probable cause for loss of floodlight #4 to be a failed ballast B in FEA #2
 - Another possible cause is corona arcing in floodlight assembly, however current signature is not consistent with arching
- FEA #2 was issued to OV-104 in 1996 in support of flight 16
 - FEA #2 has successfully supported 7 missions prior to STS-98

- Adequate system redundancy exists
- Low probability of failure in ballast assembly with modified ballast
 - Last failure of a ballast assembly was in February 1998
- OV-103 payload bay floodlights have successfully passed OMRSD testing

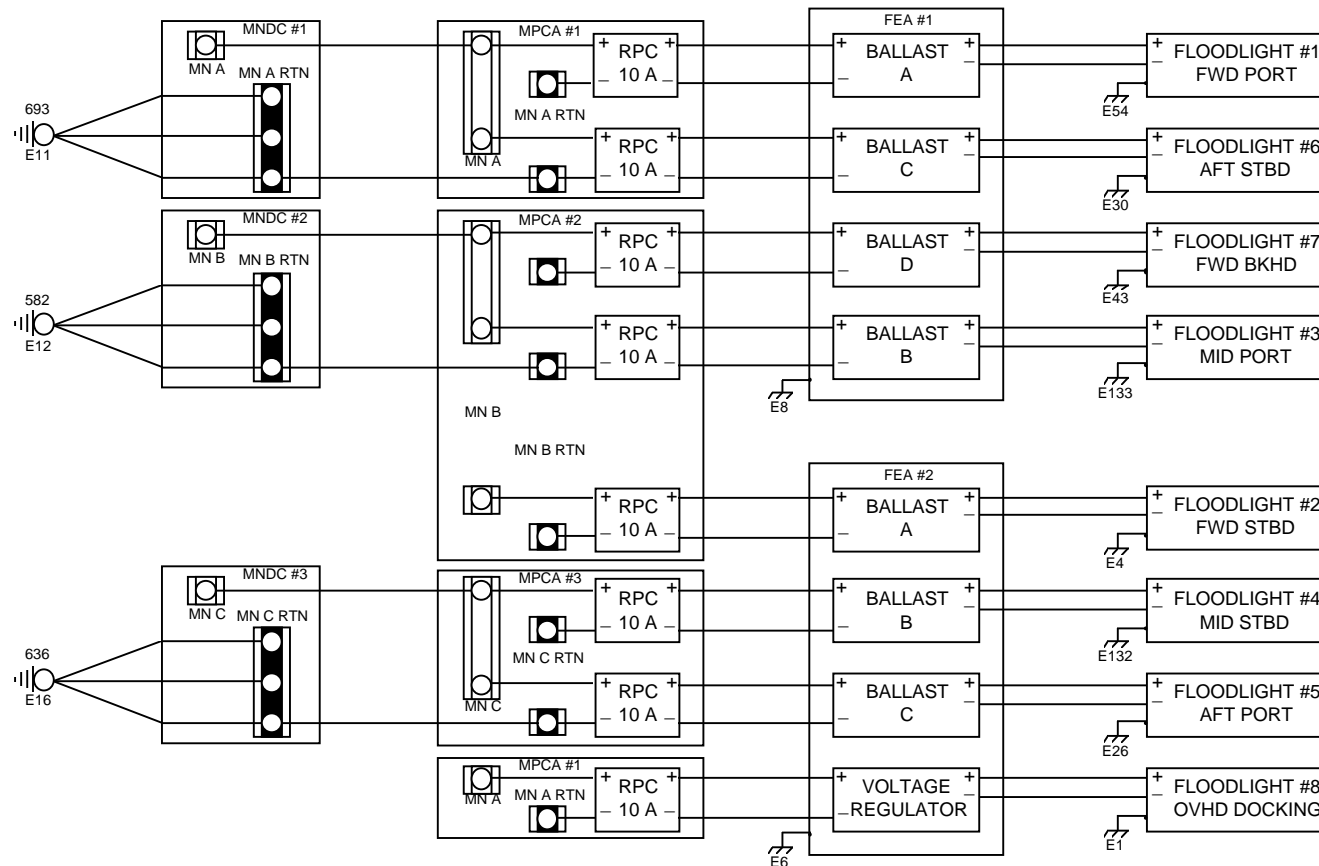
Overview of Payload Bay Floodlight System

- FEA #2 contains 3 ballast assemblies and 1 voltage regulator
 - Each ballast assembly powers its own individual floodlight
 - Voltage regulator is used to power overhead docking floodlight
 - Failure of one ballast will not affect other ballasts or regulator
- Most likely component failure in ballast assembly is the transistor Q6
 - Failure of transistor Q6 is usually a collector to emitter short due to electrical overstress
 - Transformer T1 in ballast assembly may be a contributing factor to the overstress of transistor Q6
 - Transformer T1, due to a marginal design of its “fly-back” operation, tends to become saturated causing Q6 overstress

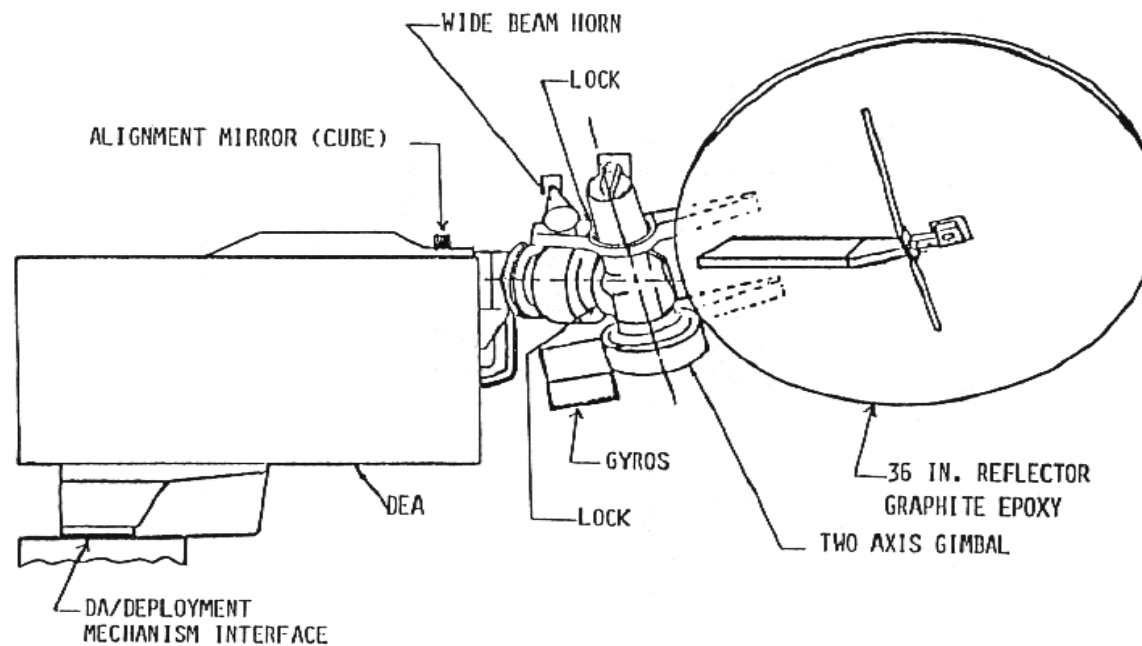
- Post-flight troubleshooting determined that the cause of problem was within the DEA Exciter circuitry
 - The Ku-Band DA (S/N 102; which includes the DEA) was removed on 11-20-00 and sent to NSLD for failure isolation and repair
 - Troubleshooting confirmed to the component level
 - Q5 transistor on the A3A1 Harmonic Phase Comparator Circuit Card was found to be bad
 - Transistor had an open Base-Emitter junction which prevented conduction and subsequently phase-lock within the DEA
 - Component was removed and replaced
 - DEA will undergo solder rework

- A replacement Ku-Band DA (S/N 107) was installed and failed OMRSD testing due to frequency spurs (noise) observed in radar and communication mode frequencies
 - Spurs were consistent, observed after each power-up sequence and affected communication performance
 - Observed high bit error rate along with poor TV picture quality
 - Two of the five radar frequencies had spurs
 - Could affect radar performance on orbit
- Ku-Band DA (S/N 107) was removed and replaced with Ku-Band DA (S/N 108)
 - All OMRSD testing (S/N 108) has been completed successfully

- Discrepant OV-103 Ku-Band system hardware has been removed and replaced with a flight spare
- Comm and radar workarounds are available
- All Ku-Band system OMRSD testing has been successfully completed

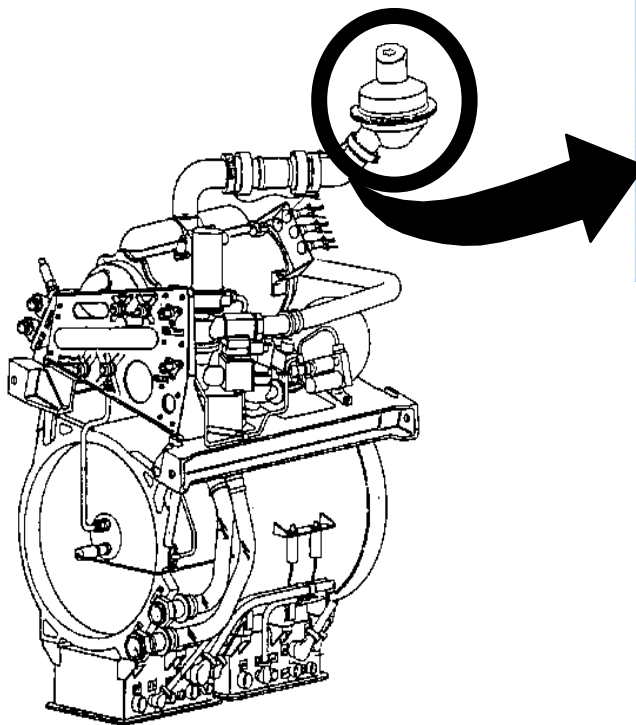
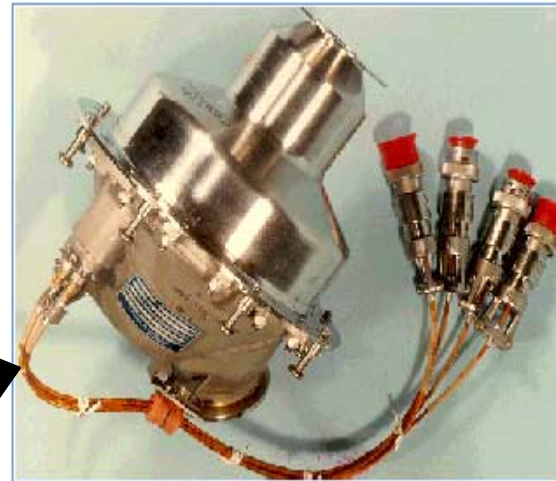
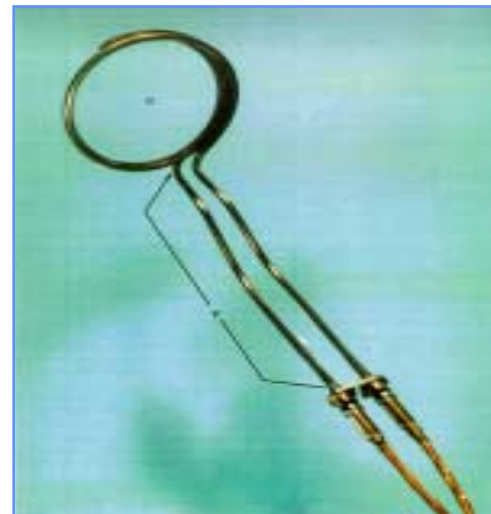
Water Spray Boiler Assembly & Controllers

- Water spray boiler (WSB) 2B steam vent nozzle heater dropped off-scale low (<122 °F) during STS-92 pre-entry
- WSB 3B steam vent nozzle heater failed to operate during STS-92 pre-deorbit

- Vent nozzle heater failure can cause the loss of WSB due to orifice icing/blockage

- Review of STS-92 flight data shows that both vent nozzle anomalies are due to vent nozzle heater failures
- Six previous flights experienced similar anomalies which were attributed to erratic cycling/heater braze joint failure
 - STS-61C, -41, -39, -43, -53 & -86
- In the existing design, heaters are not hermetically sealed, making the heater coil susceptible to corrosion/oxidation cracks at the braze joints
 - A design mod is in the process of being implemented to manufacture and procure hermetically sealed coil heaters (-004 configuration)
 - Both failed heater assemblies have been replaced
 - System #3 has the new hermetically sealed (-004) units

- Two of the three OV-103 vent nozzle heater assemblies have been replaced
 - System #3 has the new hermetically sealed units
- Each of OV-103's WSB systems passed OMRSD checkout during the STS-102 processing flow
 - Vent nozzle heater performance will again be verified when heaters are turned on prior to launch
- Each vent nozzle assembly has a fully redundant heater system

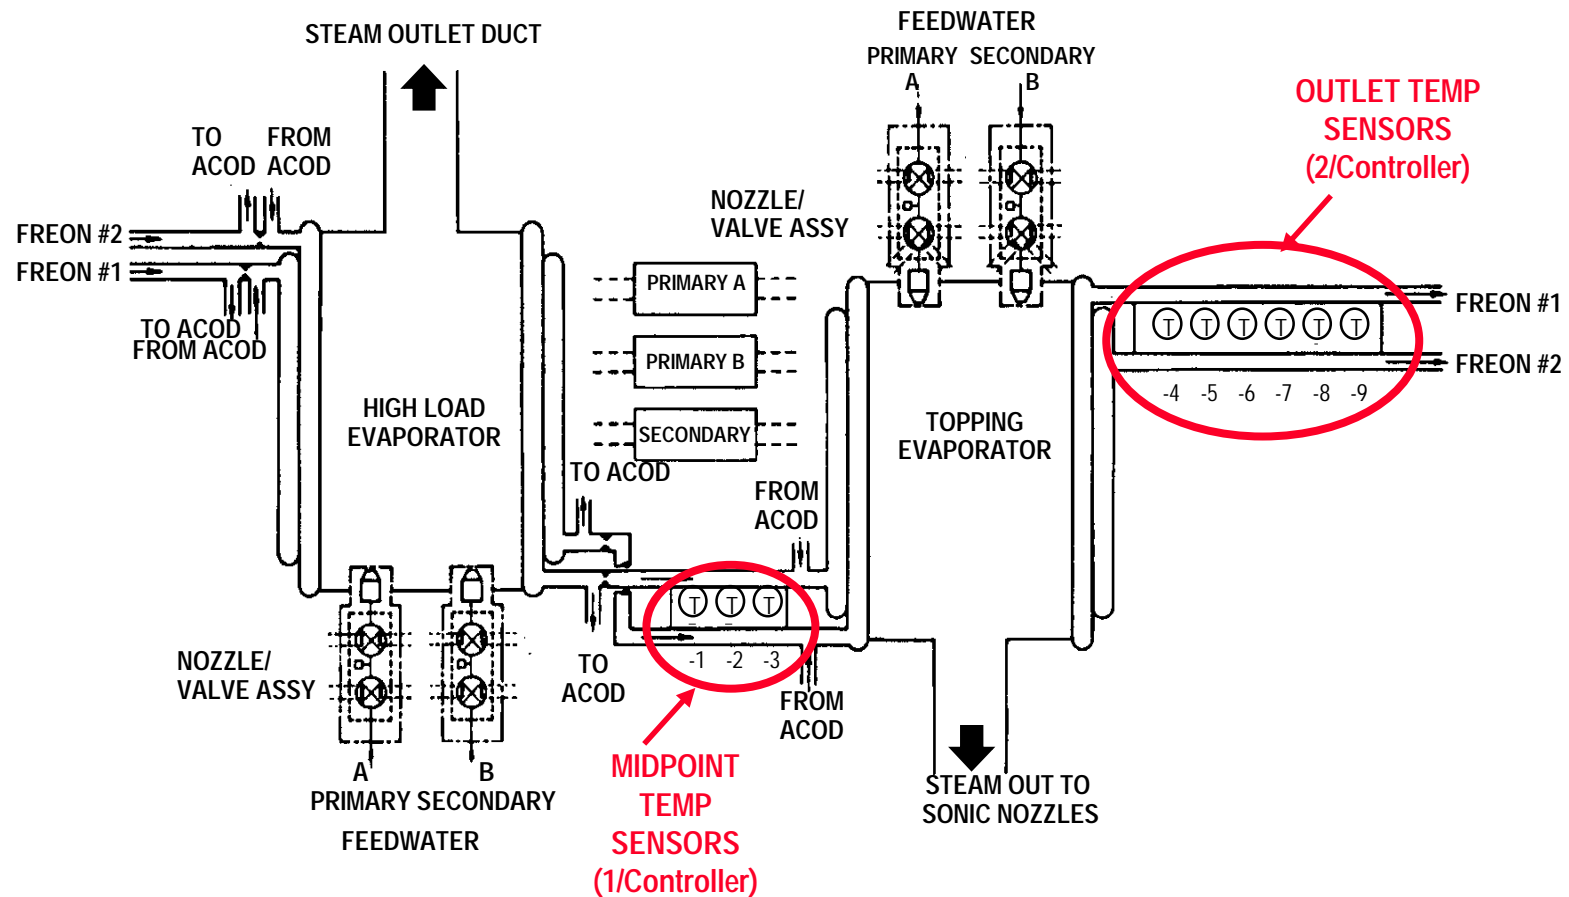
Organization/Date:
Orbiter/02-27-01**FLASH EVAPORATOR ASSEMBLY SCHEMATIC**

- Prim B Full-Up mode typically used for entry if Prim A Full-Up used for ascent, and vice versa
- During STS-92 de-orbit prep FES checkout activity, the FES shut down when operated in Prim B Full-Up
 - Following a core flush, Prim B was reactivated, but again shut down
- In total, all 7 modes of operation were run at some point during the mission, providing some data for evaluation of controllers, cores, water spray valves, and sensors
- Flight data led to initial belief that Midpoint sensor B was cause of the problem
 - Freon temperature oscillation looked similar to one produced by a degraded midpoint sensor block that has an air gap between the sensor and the block's thermal mass
 - FES midpoint sensor problems have caused shutdowns in the past

- In-flight data validated the integrity of the “B” hi-load and topper valves
- Cause of STS-92 shutdown is most probably due to a combination of FES aging and activation at low outlet temp (70F-75F)
 - 62F-85F is known to be a sensitive range where FES is more likely to shut down in a degraded FES
 - Low outlet temp produces low water supply flow rate, low back pressure in the core (water triple point), and consequently increases likelihood for a small amount of icing in a degraded FES
 - Icing reduces cooling efficiency and can lead to the shutdown
- OV-103 FES S/N 8 has original Hi-Load Core that was built in 1983, flown 15 flights since 1985
 - Previous S/N 7 also experienced age related/degraded performance shutdowns after about 15 flights

- PRT has recommended (including NASA DCE) FES be accepted to fly as is
- PR has been deferred for one flight
 - FES performance will be monitored during the next flight and data evaluated during the upcoming flights leading up to the next OMM for a planned replacement of S/N 8
- MOD is being requested to consider allowing FES outlet temp to go higher, near 85F, before activating FES
 - Crew to wait for a few more seconds to allow further temperature climb

- Cause of STS-92 is most likely due to a combination of FES aging & activation at low temp
 - Problem can be prevented by instructing crew to activate FES at higher temp – Option being evaluated by MOD
- Observed core degradation is not expected to significantly impact FES performance prior to OMM
- System redundancy and in-flight procedures are available to handle cooling mode loss
 - Seven modes of operation available to provide FES cooling
